Round Lake Beaches

The following is a brief history of how a beach was formed on Round Lake by a former Round Lake owner now deceased on the south shore of Big Round Lake. This is not recommended now and I believe is not legal without DNR permits.

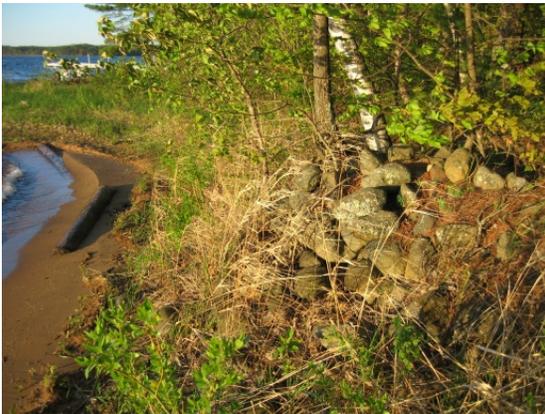
Residua of fieldstone dam that once went 15 to 20 feet into water. The top left part of picture shows few thousand square foot beach now present with mature cover.

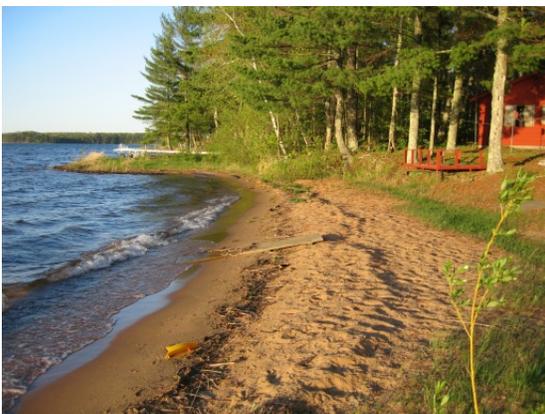
This beach was made with fieldstone berm or dam and the water once went up to the old red deck by the shoreline. At the top

upper left shows the other beach formed by a berm just beyond where the red deck is. The beach in the foreground was formed by a berm where picture was taken.

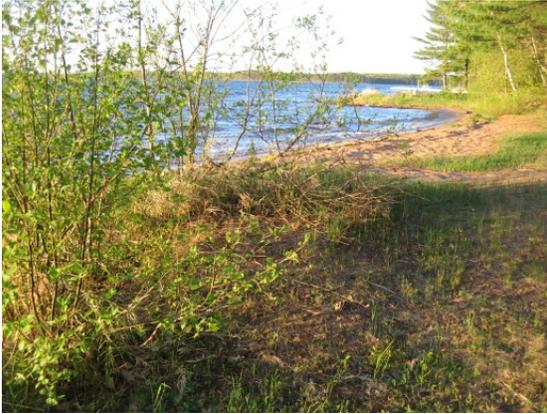
The shrubs are growing where a fieldstone berm is. The berm is covered with vegetation and there is a mound there now. The fieldstone that once protruded into the lake is covered with sand and now sunken. All of the visible beach in this picture was formed by this fieldstone berm.

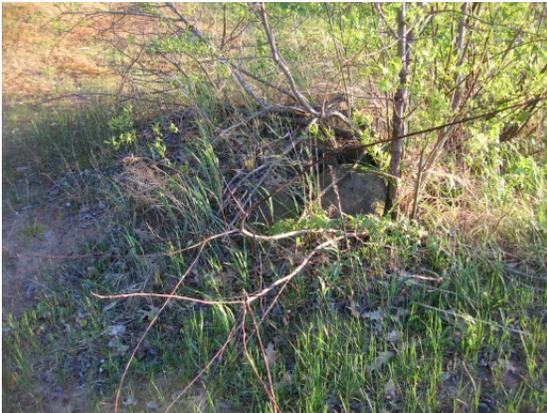
Residua of fieldstone berm on shore.

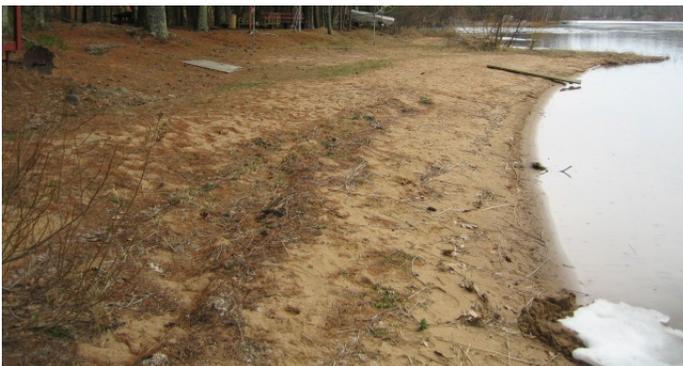
Entire Beach was made by fieldstone berm which was located at the point in the top right of picture. The water used to go almost to tree line.
